SAFETY ALERT

RISK MANAGEMENT IS KEY WHEN CONFIGURING RAILCARS FOR PERSONNEL AND EQUIPMENT

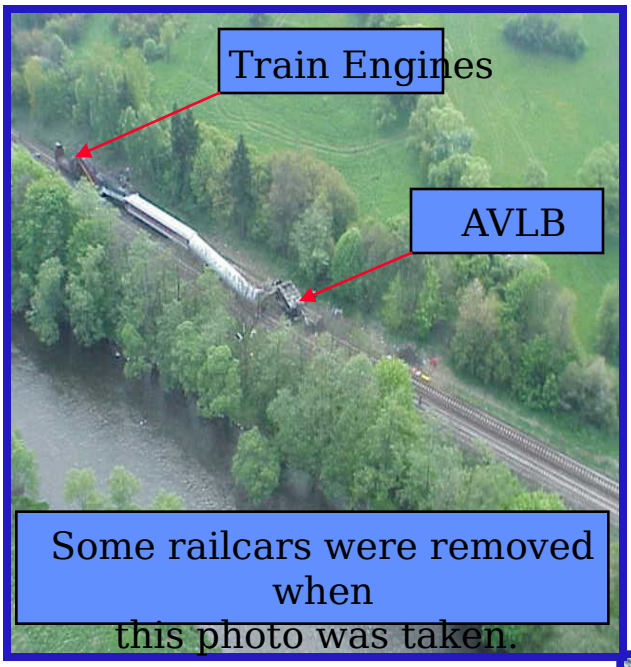
Some railcars were removed when this photo was taken.

Two trains accidentally operating on the same railroad track were involved in a head-on collision. One of the trains, carrying US Soldiers and their heavy equipment was on its way to a field training exercise.

Fourteen soldiers were injured when the railcar carrying AVLB equipment slammed into their passenger car. Fortunately, the soldiers were sleeping at the time. If they had been awake when the collision occurred multiple

The impact of the collision pushed the AVLB loaded railcar into the personnel railcar.

- ✓ **When possible, avoid configuring heavy, oversized equipment immediately behind passenger cars.**
- ✓ **Adequate separation of equipment and passenger cars is recommended to ensure the safety of our soldiers when traveling**
